Contents

Introduction

This audit covers the area bounded by Martin Luther King Jr. Boulevard, on the east by Trinity Street, on the south by 10th Street, and on the west by Lavaca Street. Outlying buildings include the William P. Clements Building located at 300 West 15th Street and the Ernest O. Thompson Building located at 920 Colorado Street.

Capitol Grounds South of 15th Street

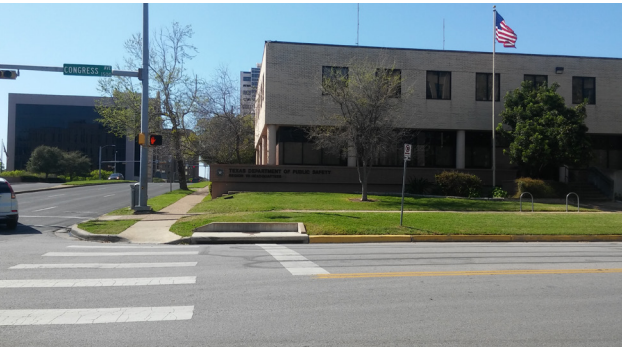
1 No orientation maps are present along either side of Congress Avenue.

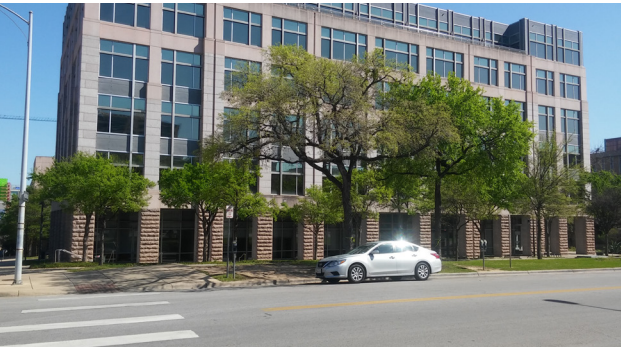
1 There are no existing Vehicular or Pedestrian Directionals leading to the Capitol.

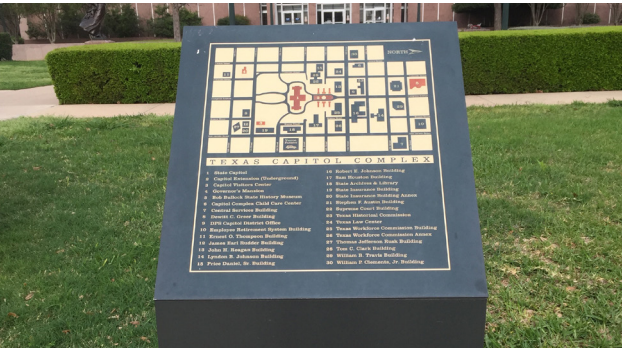
1 There are a minimal amount of orientation maps within the Capitol Grounds.

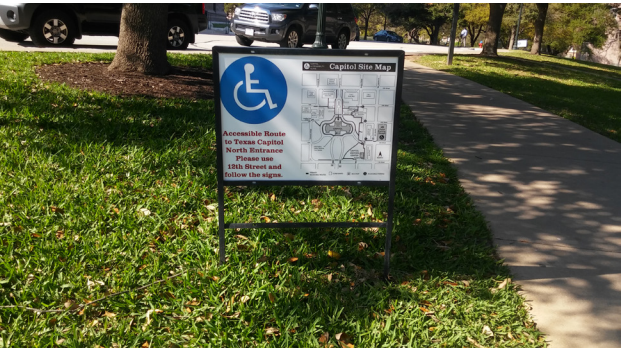
1 Accessible Route maps are poorly placed and not highly visible to the user.

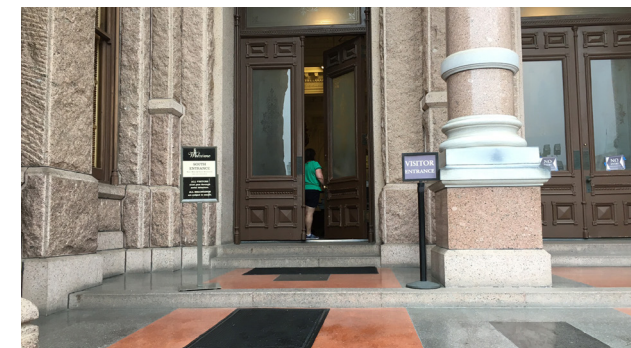
2 Capitol Entryway Identification varies in placement and utilizes temporary signage.

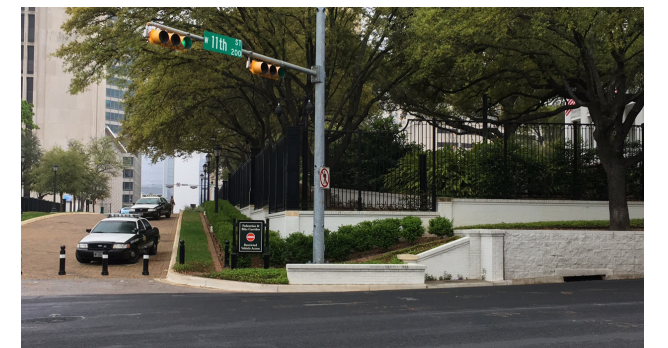
2 There are no public sidewalks that surround the Governor's Mansion, forcing pedestrians to find alternate routes.

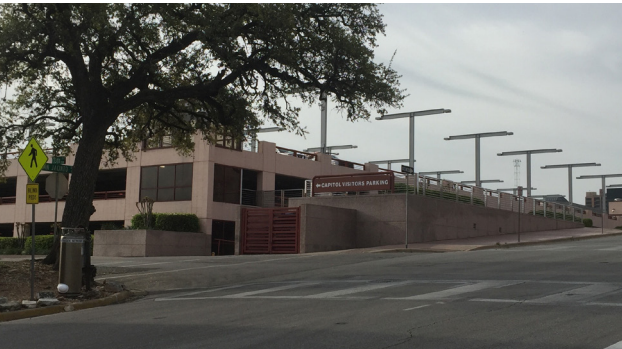
3 Wayfinding Signage directing to the Capitol Visitor's Garage Entrance is minimal and not prominent to vehicular traffic.

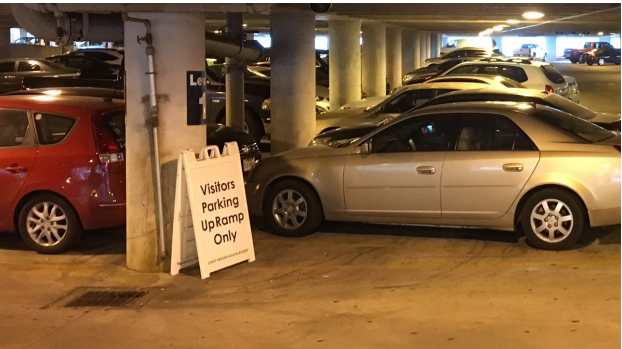
3 Temporary Signage within the Garage varies in placement and visibility.

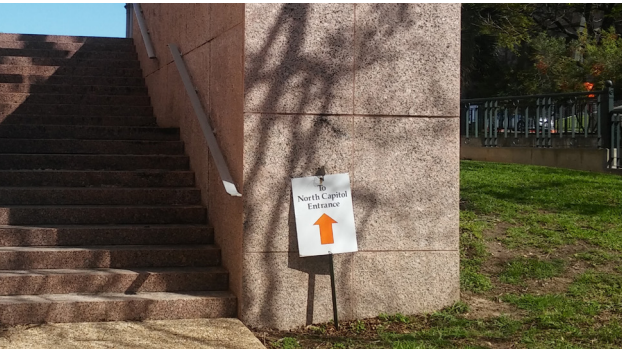
3 Temporary signage is used within the Capitol Grounds to direct to major entryways.

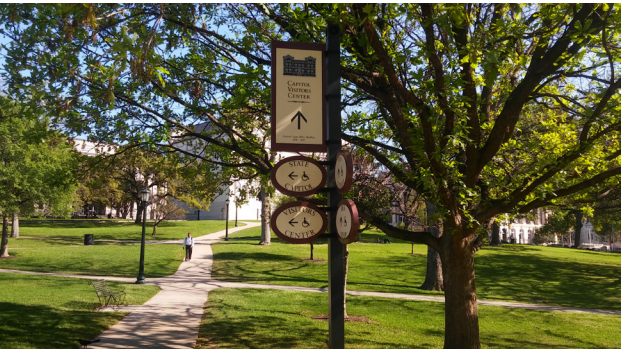
3 Pedestrian Signage within Capitol Grounds does not direct back to surrounding destinations such as the Bob Bullock Museum.

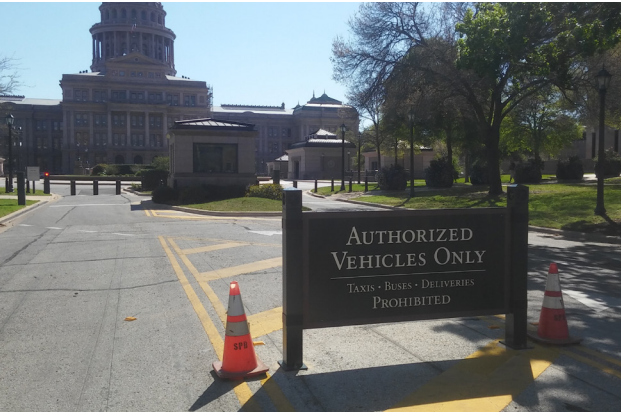
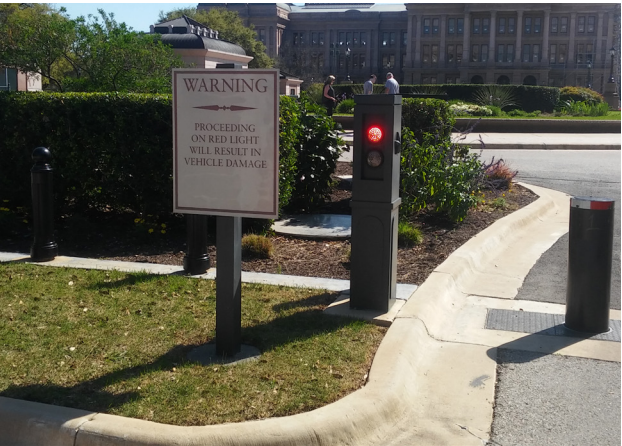
3 Signage is unwelcoming and typically negative in tone.

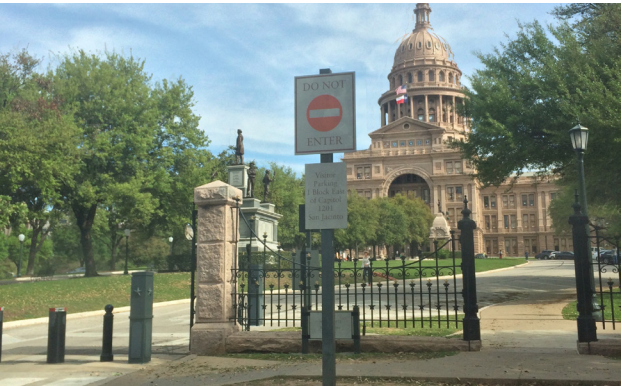
2 Signage directing to the Visitor Parking is minimal.

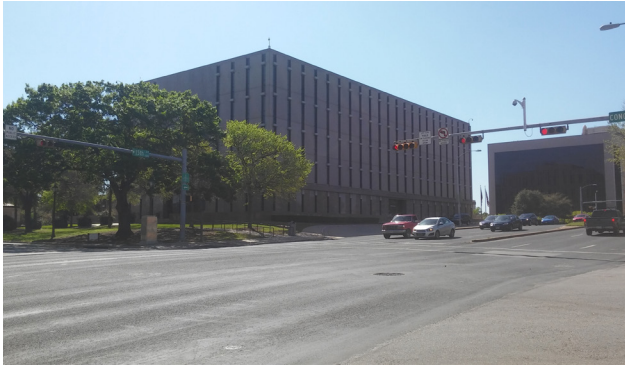
3 Building Identifiers are not clearly visible to vehicular traffic at greater distances.

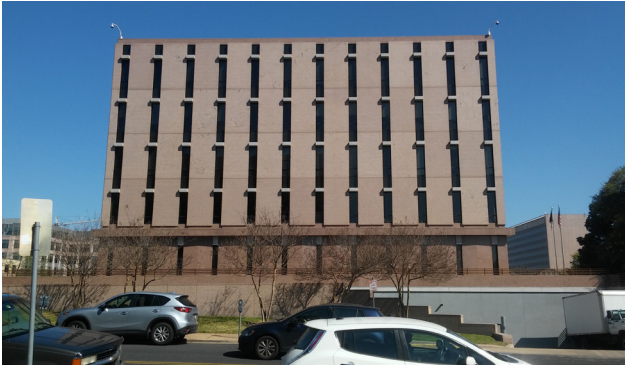
Building markers are not visible from every facade.

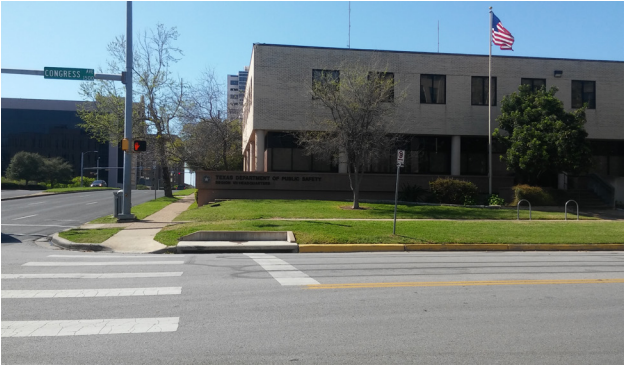
3 The Texas Department of Public Safety does provide a clear and visible building identifier from various distances.

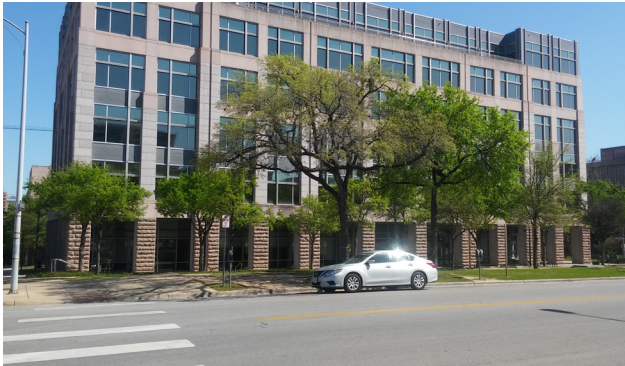
3 Building Names are obscured by landscaping and environmental obstructions.

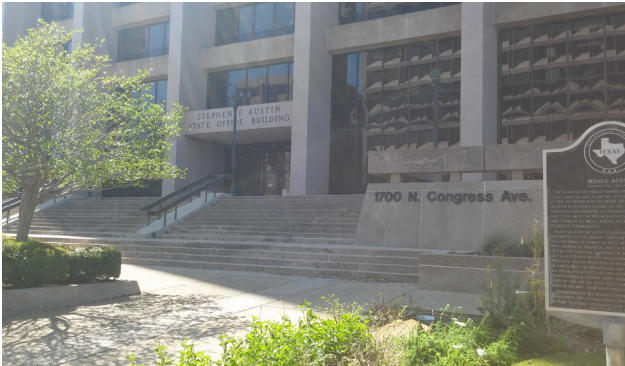
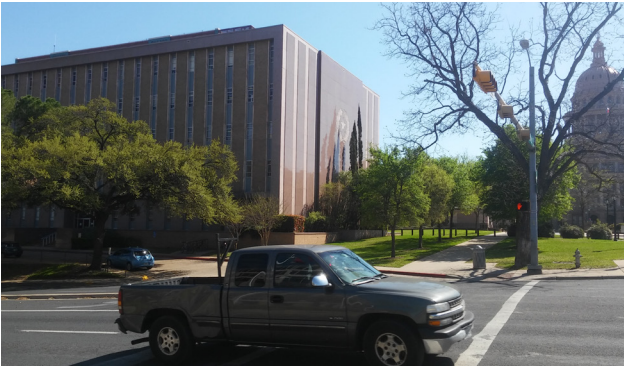
3 Building ID's are not clearly visible from pedestrian crossings.

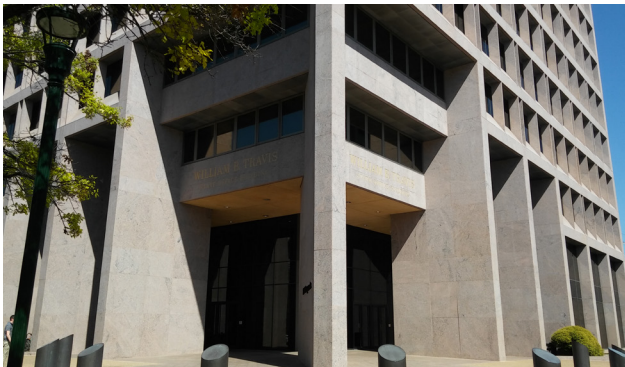
Identifiers are not clearly legible due to placement and lack of contrast of letterforms with their background.

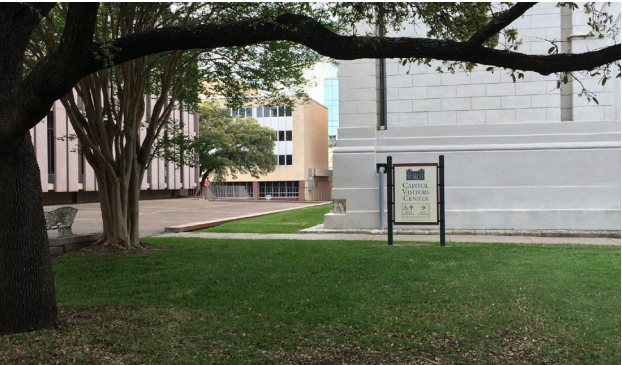
2 Capitol Visitor's Center Signage varies in format.

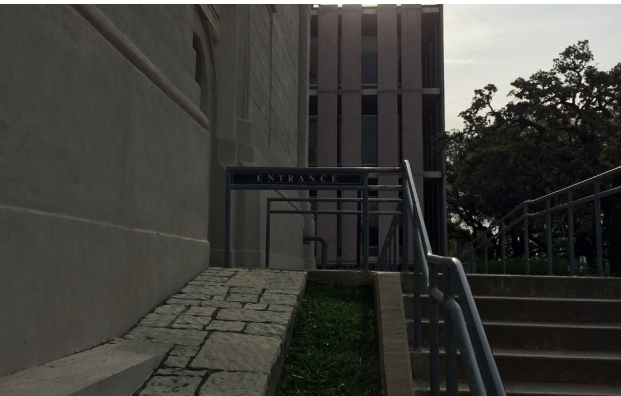
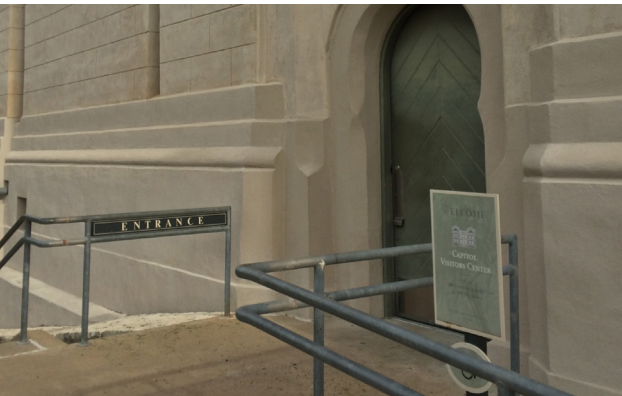
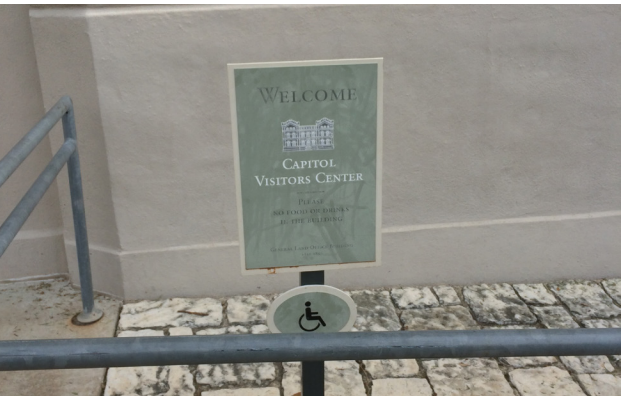
Entrance Signage is not clearly visible for pedestrians from greater distances.

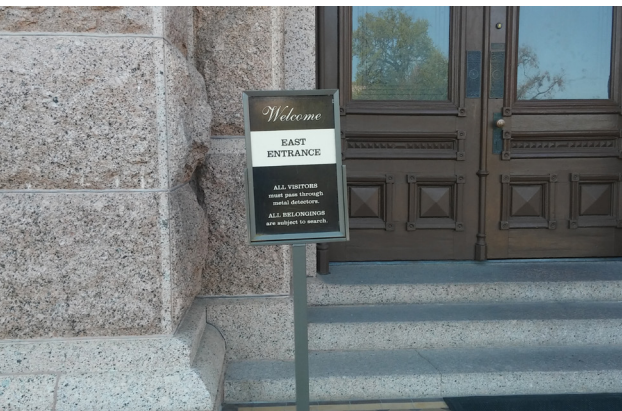
2 Capitol Entryway identification varies in placement and utilizes temporary signage.

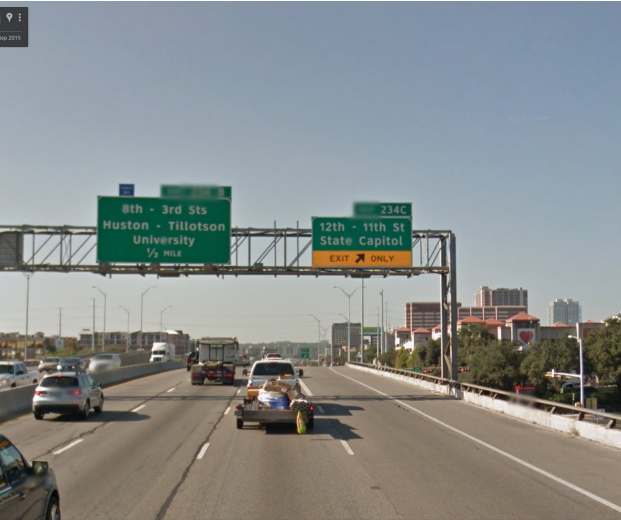
2 Vehicular signage is clear for directing to the Capitol. Signage directs to the Capitol building itself, and not necessarily the Capitol Complex.

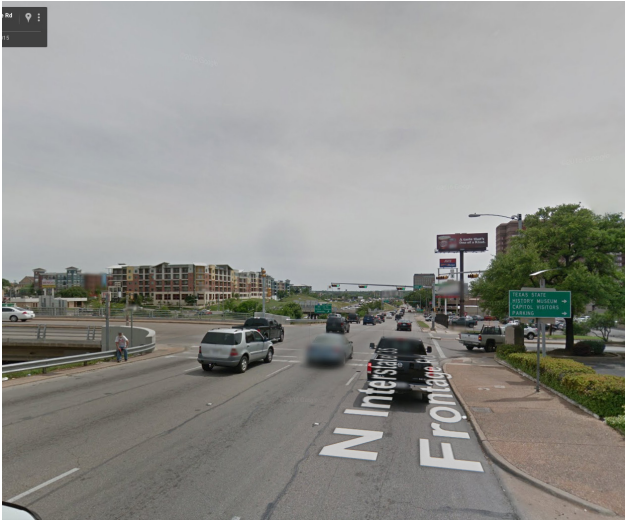
2 Vehicular Signage that directs to Major Landmarks is minimal and is typically City of Austin signage.

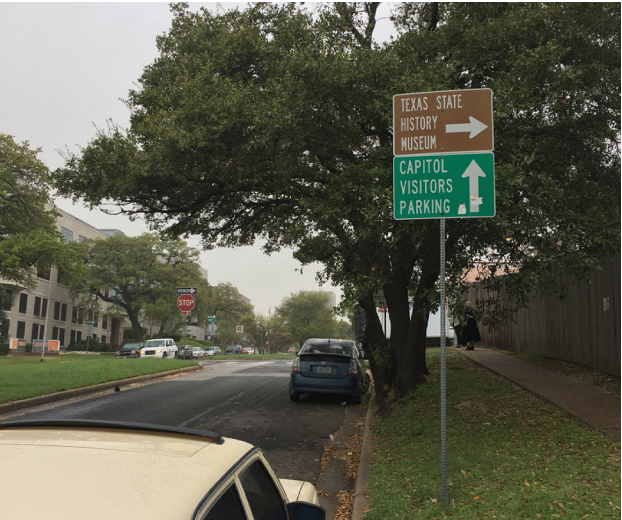
Signage lacks clear direction into the Capitol Complex and does not define its boundaries.

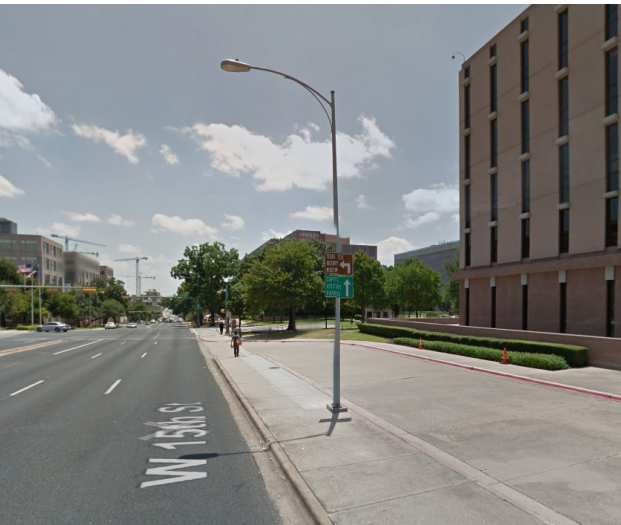
3 Vehicular Wayfinding to the Capitol Visitor's Parking Garage is minimal and typically produced by the City.

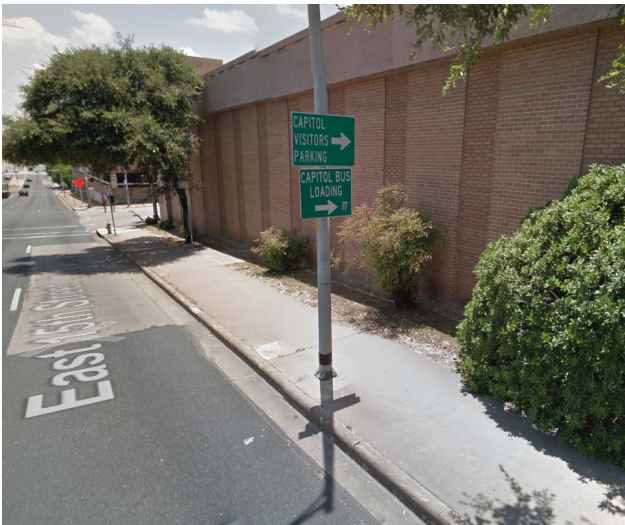
3 Wayfinding signage directing to the Capitol Bus Loading Zone is inconsistent.

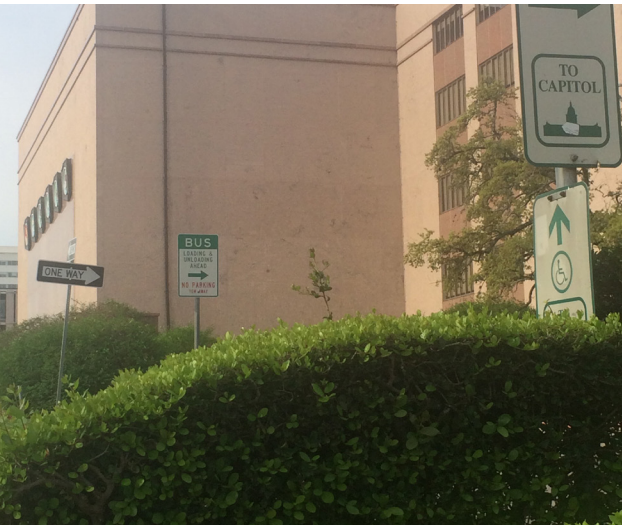
3 Vehicular signage is sometimes obstructed by landscaping elements.

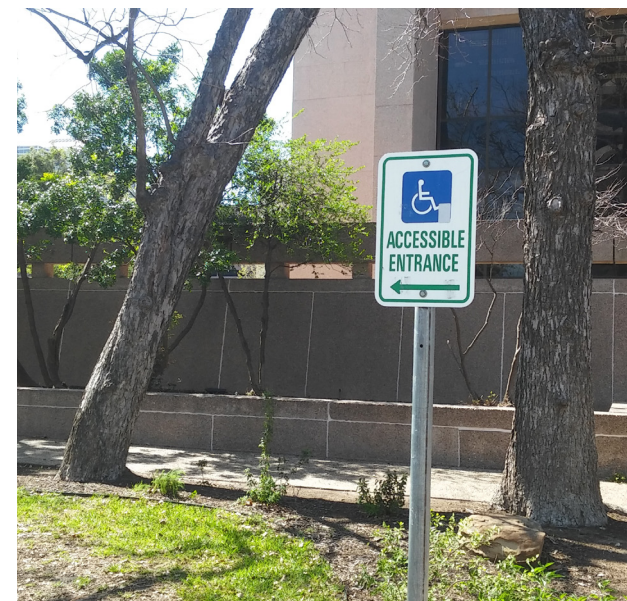
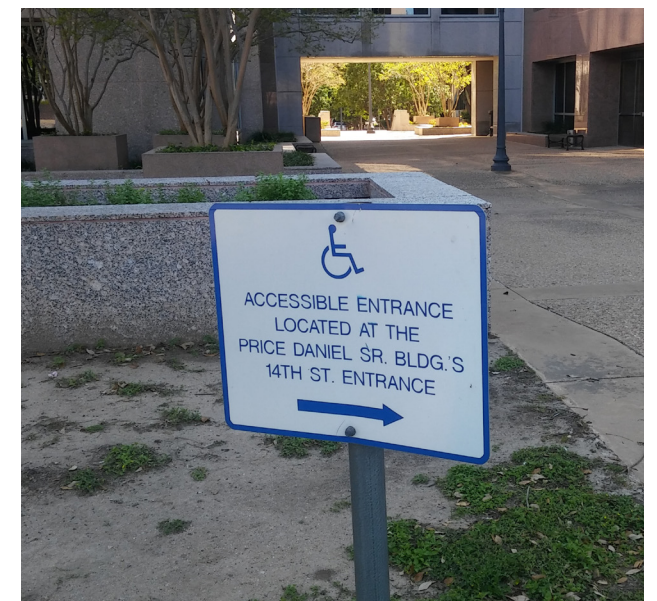
Accessible Route Signage varies in styling, messaging and overall presentation.

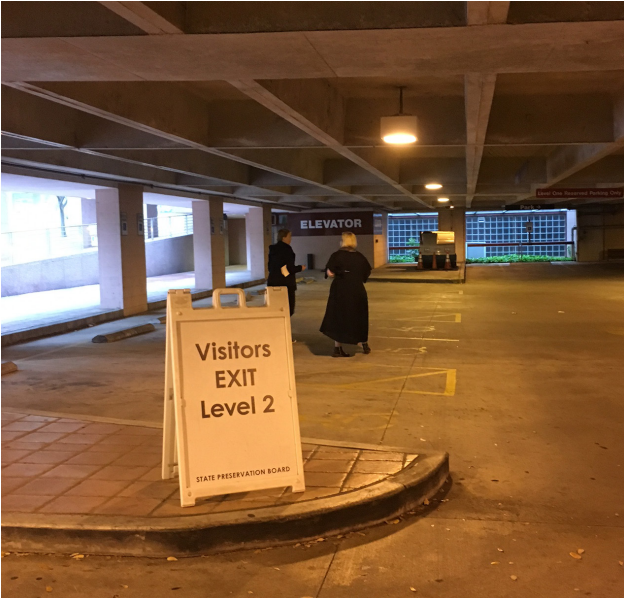
3 Temporary Signage is used throughout the Garage for wayfinding needs.

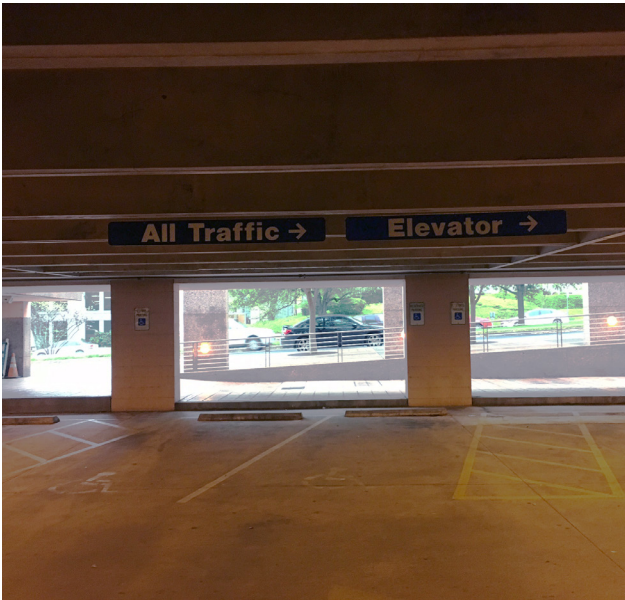
3 Overall design is not consistent with wayfinding signage within Capitol Grounds.

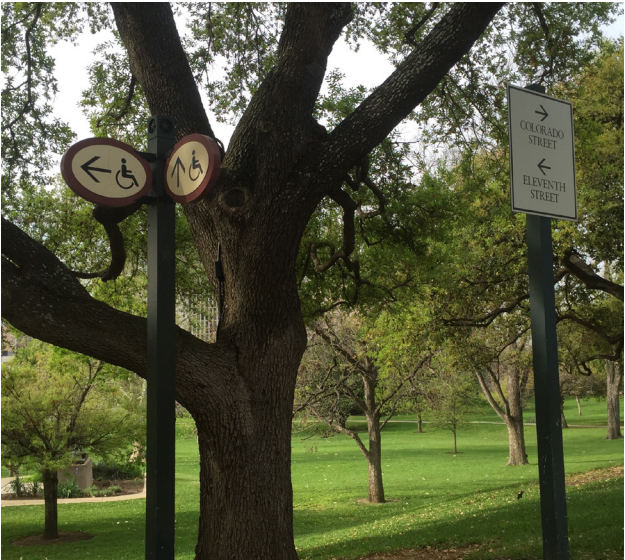
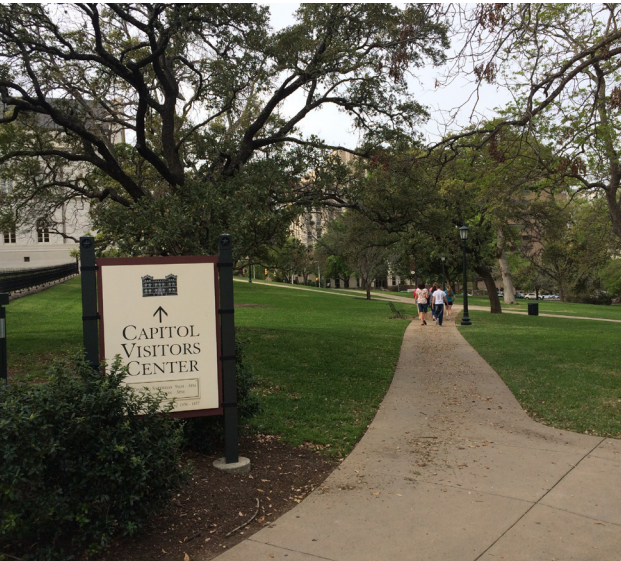
3 Existing Wayfinding Signage is partially obscured by landscaping.

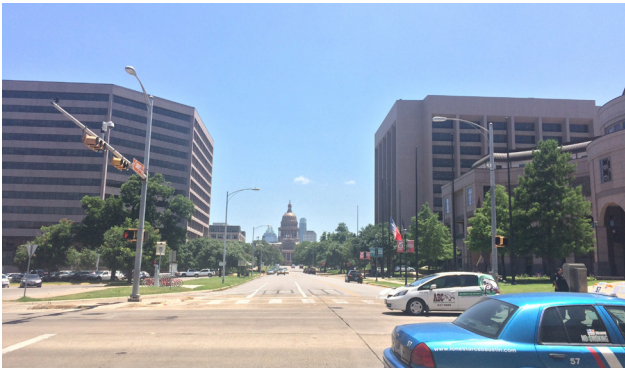
4 There is a lack of district demarcation announcing entry into the Capitol Complex.

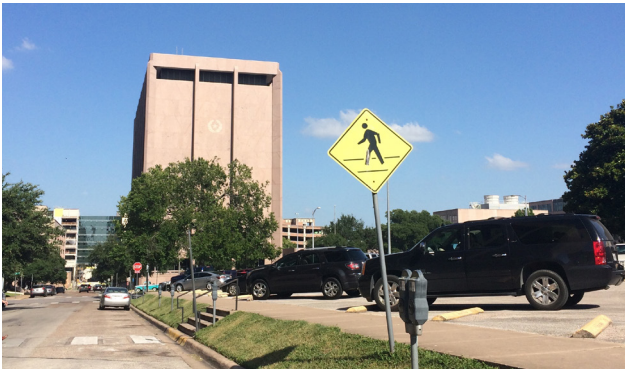
4 Pedestrian crosswalk signage is minimal and oddly placed.

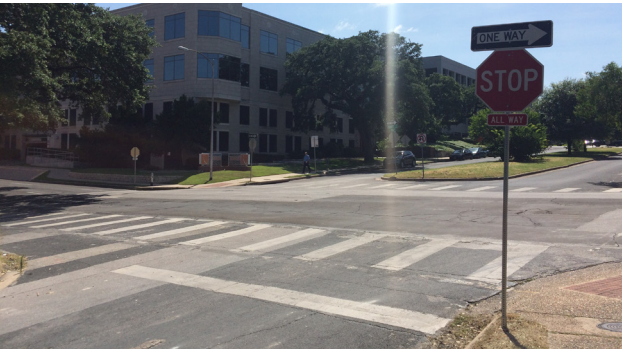
5 There is no signage targeted towards cyclists directing to designated bike paths as you enter the Capitol Complex.

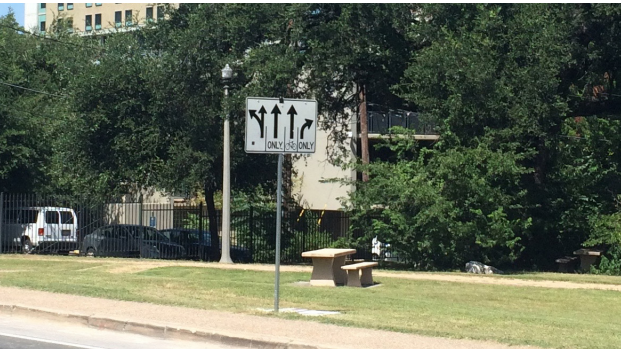
5 Signs that identify bike lanes is minimal and typically represented through city signage.

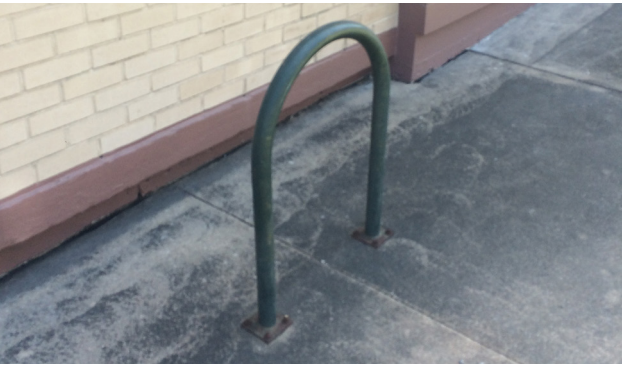
5 Bike Racks within the Capitol Complex are minimal in quantity and are not prominently visible from the street.

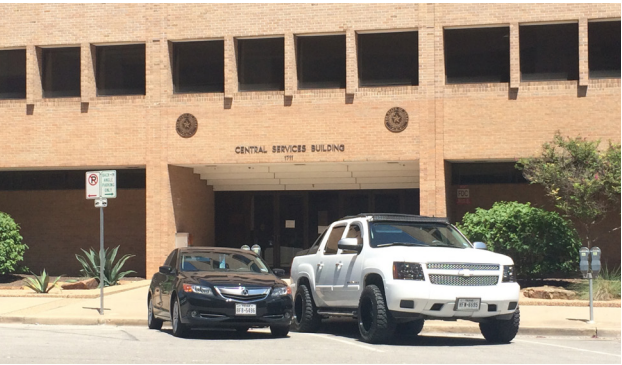
5 Building numbers are too small to read at most distances.

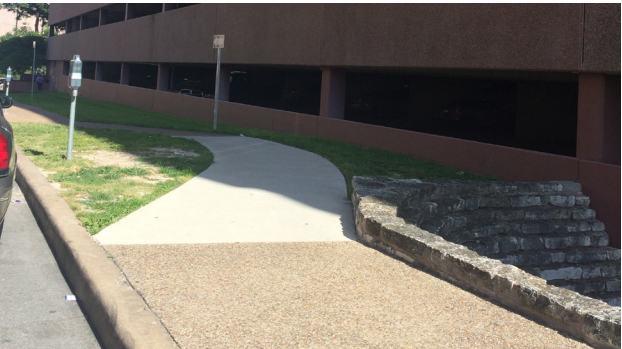
6 There is a lack of Pedestrian-facing signage that directs to major destinations or landmarks within the Capitol Complex.

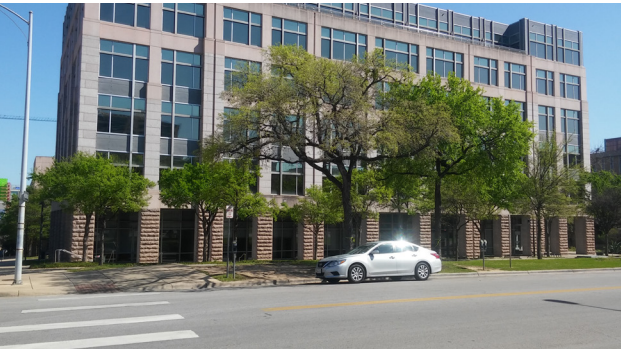
6 Identification for the Robert E. Johnson Building is obscured by landscaping.

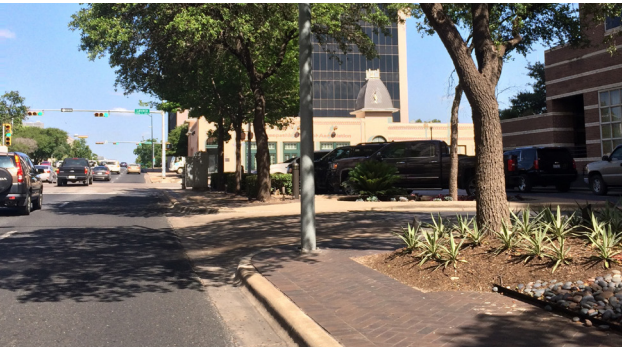
7 Vehicular Directionals are minimal in nature, even on major roadways.

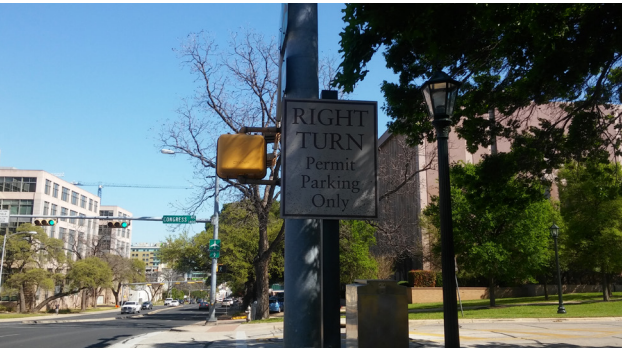
7 Vehicular Regulatory Signage is not clearly visible due to placement and shade from landscaping.

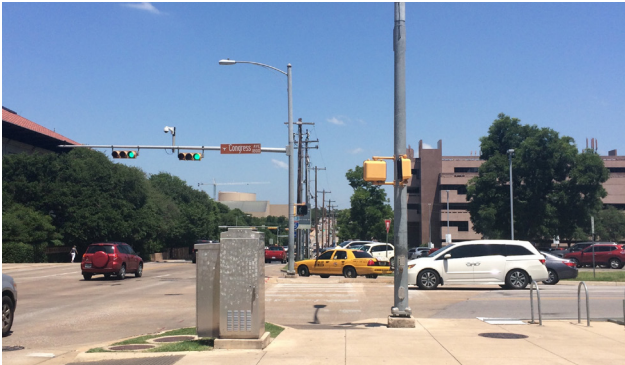
4 The Capitol Complex does not have a Gateway presence along MLK.

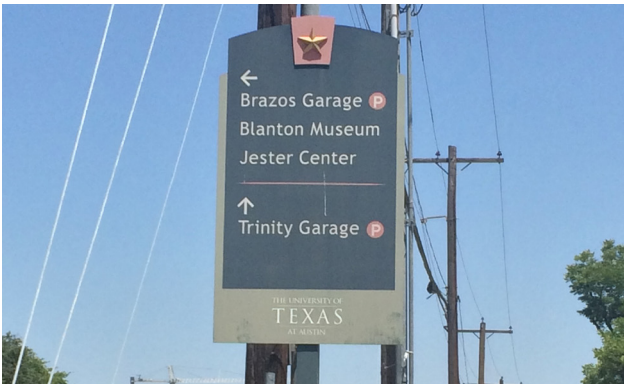
4 University of Texas directional signage on the South side of MLK and does not direct to Capitol Complex at all.

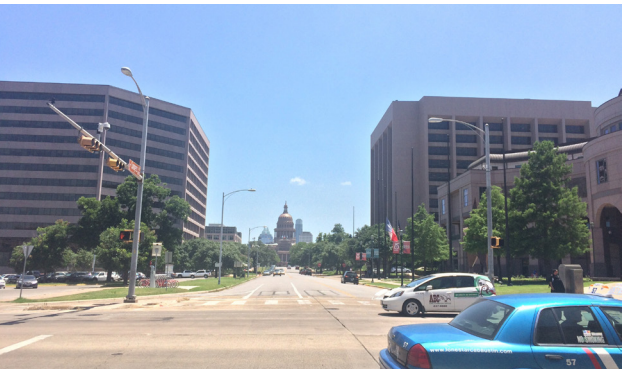
4 No sense of arrival or formal entry to Capitol Complex.

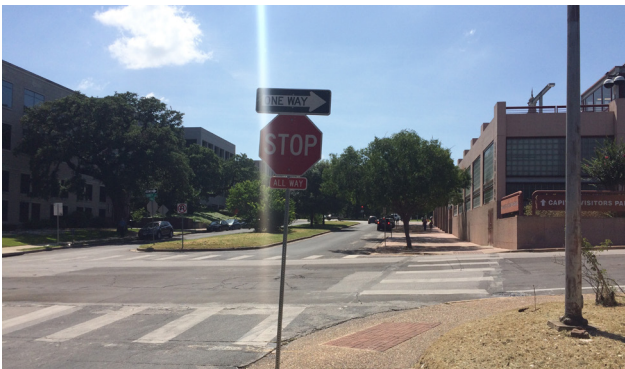
4 There is a general lack of signage announcing Capitol Complex or district demarcation.

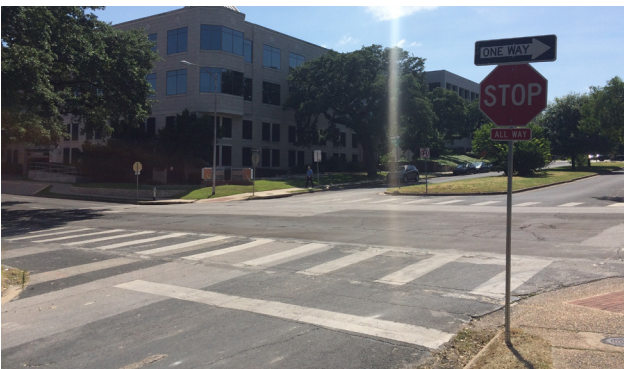
4 There is a general lack of signage announcing Capitol Complex or district demarcation.

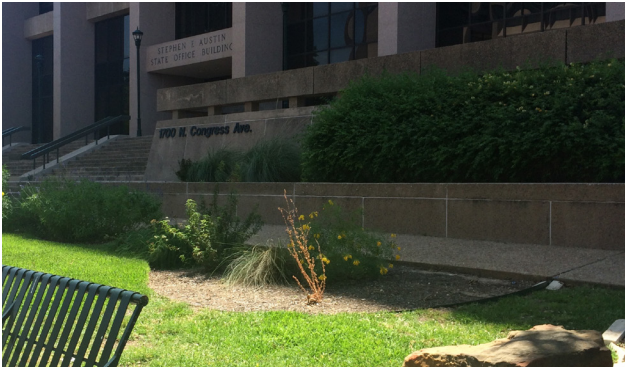
4 Building Identification is inconsistent in location and does not appropriately address pedestrian or vehicular traffic

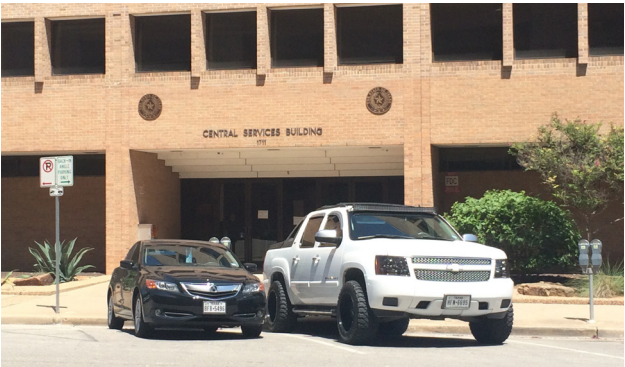
5 Building numbers are too small to read at most distances and there is no signage targeted towards vehicles.

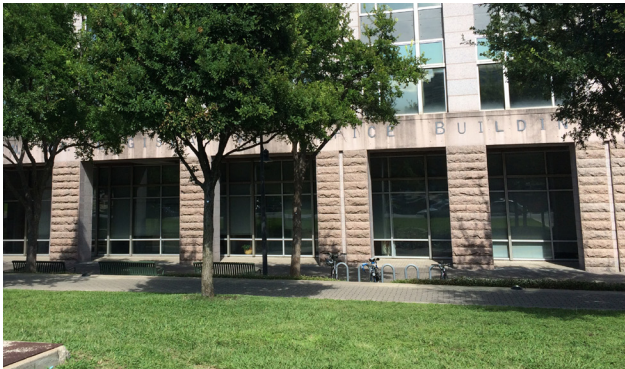
4 Signage is often obscured or hidden by landscaping.

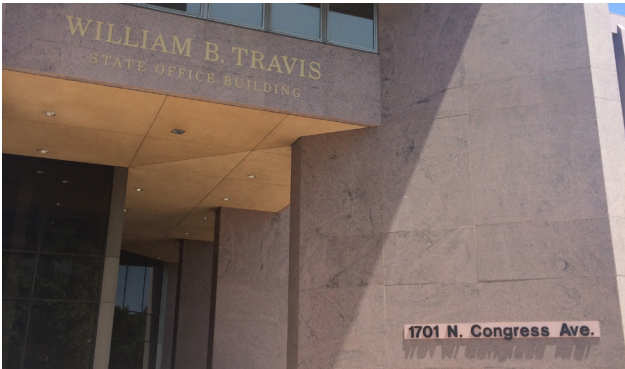
4 Building Identification is inconsistent in font, size and color.

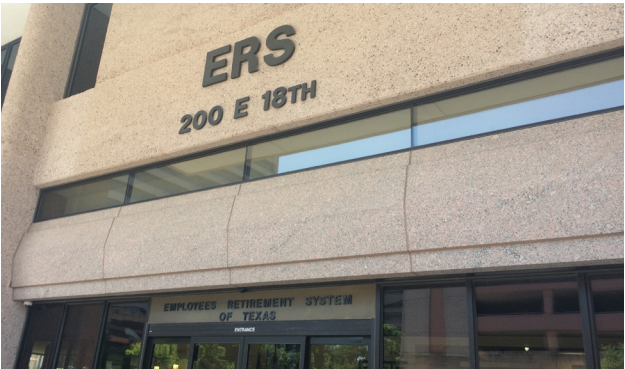
Signage is inconsistent in content at some entries. Legibility varies from entrance to entrance.

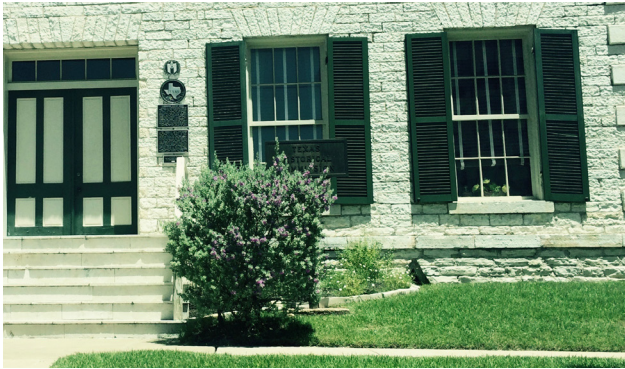
Freestanding signage is small, dark, hidden by landscaping and set back from the street.

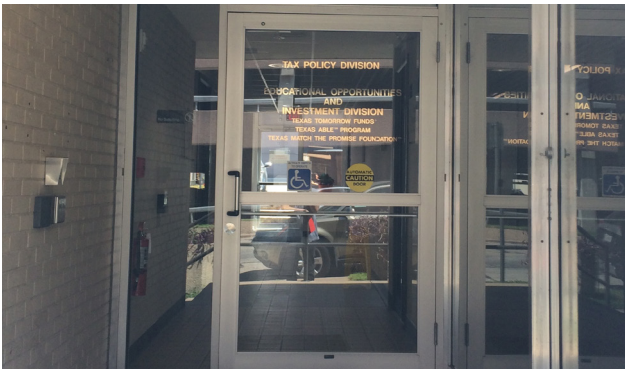
Messages are difficult to read and lack street presence.

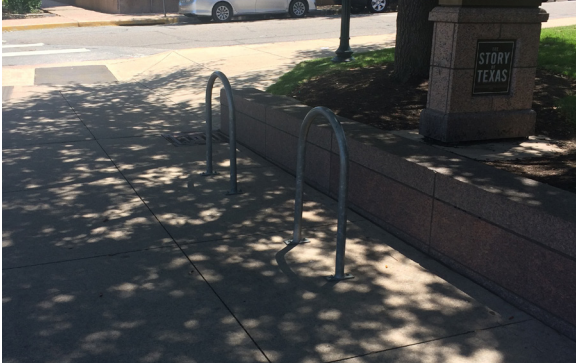
4 Bike Racks within the Capitol Complex are not marked and are not clearly identified.

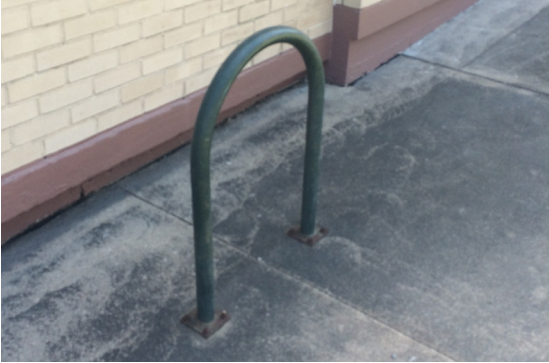
5 Bike Racks within the Capitol Complex are minimal in quantity and low in visibility.

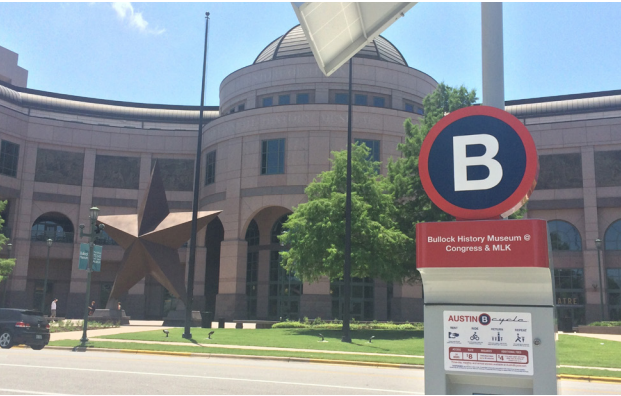
4 B-Cycle Stations identify landmarks and locations but do not provide any indication of whether or not the user is within the Capitol Complex Boundaries.

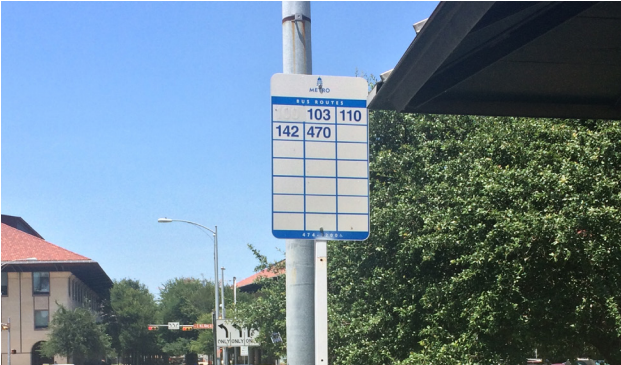
4 Signs are minimal in nature.

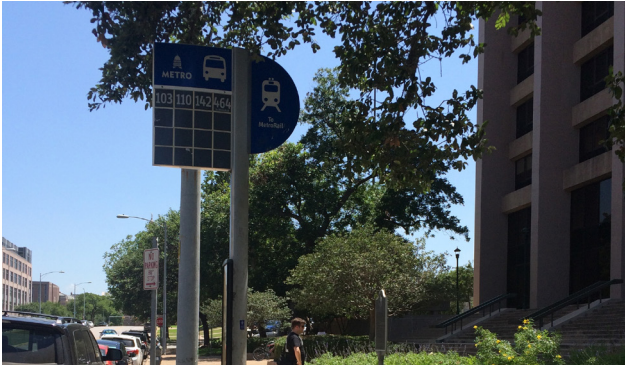
4 Signage types vary in format.

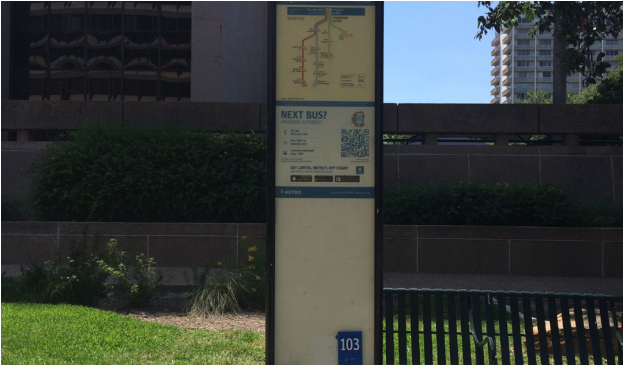
4 Routes do not denote Capitol Complex.

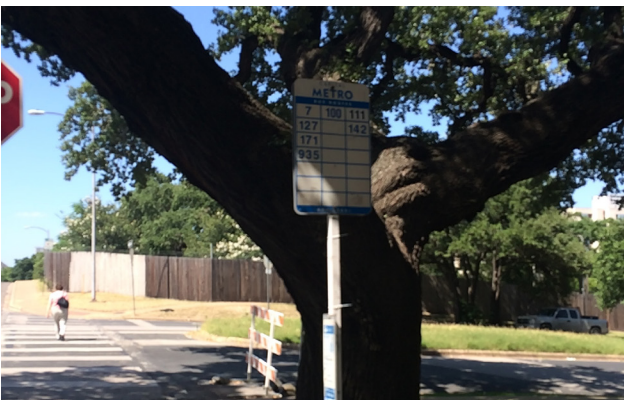
6 Signs are inconsistently maintained.

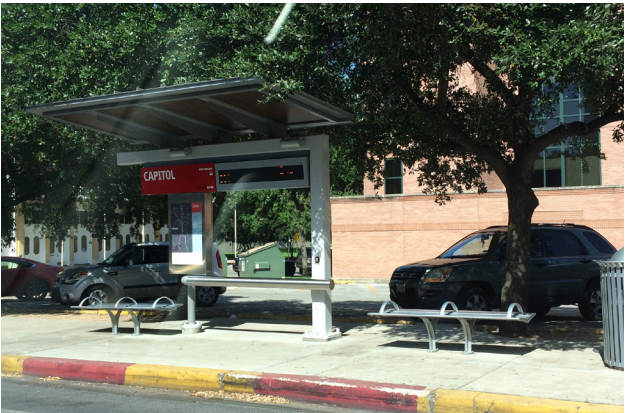
6 One of the few instances where a bus stop has any physical shelter or seating. Capitol stop still does not refer to the Complex.

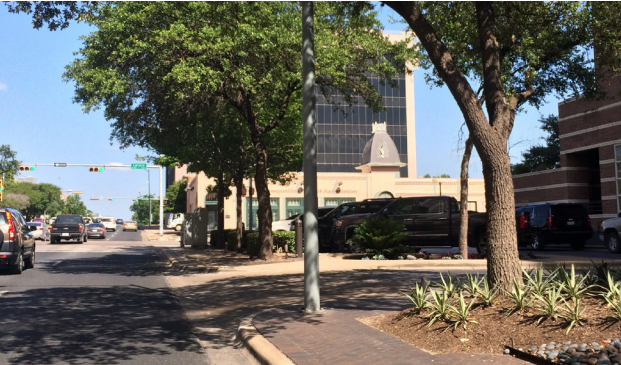
7 Vehicular directionals are minimal in nature, even on major roadways.

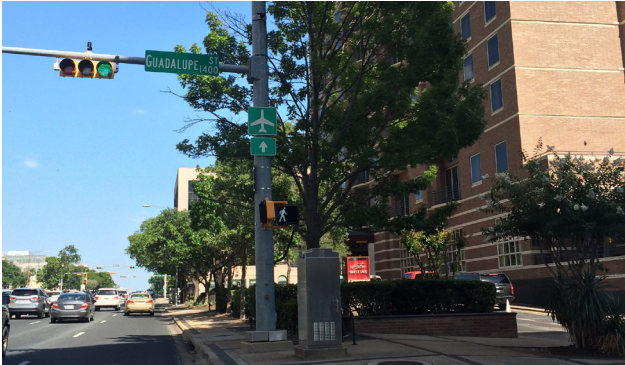
7 Signage armatures and infrastructure are inconsistently installed and maintained.

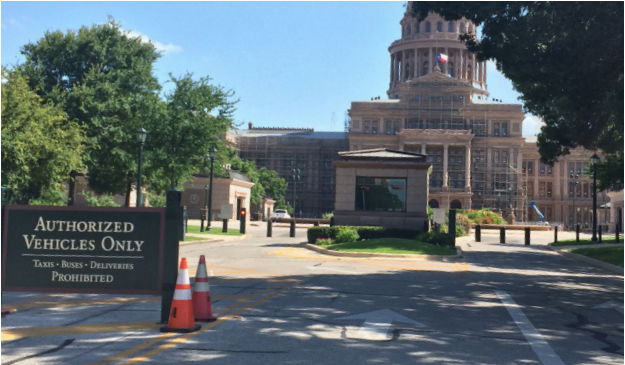
7 Signage at the Capitol does not direct to alternative routes or methods of entry or directions to nearest the visitor parking.

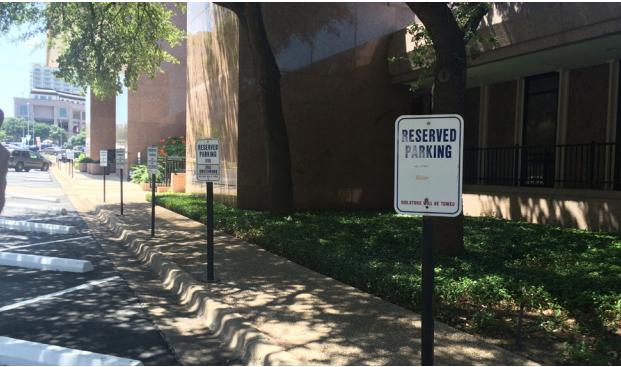
Signs do not indicate intended parking user type. Signs use inconsistent fonts and formats.

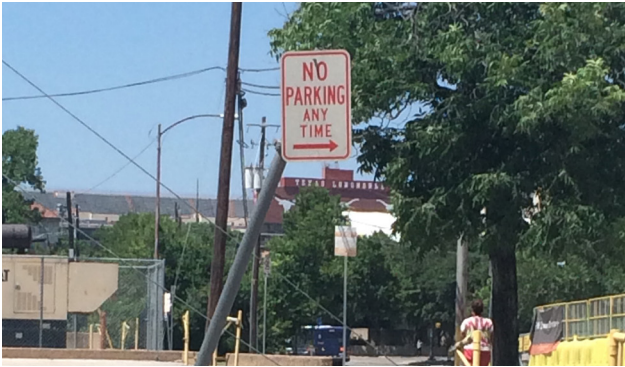
Signage armatures and infrastructure inconsistently installed and maintained.

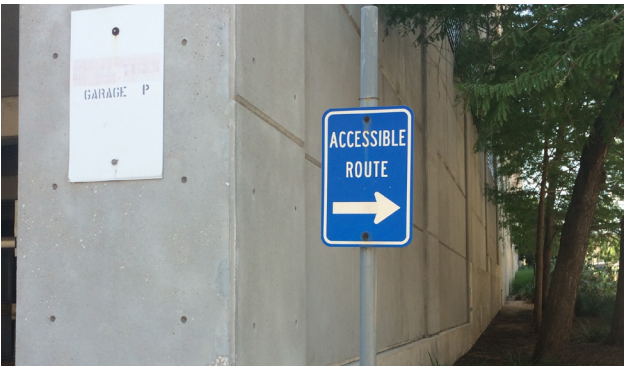
Accessible route signage is minimal in nature.

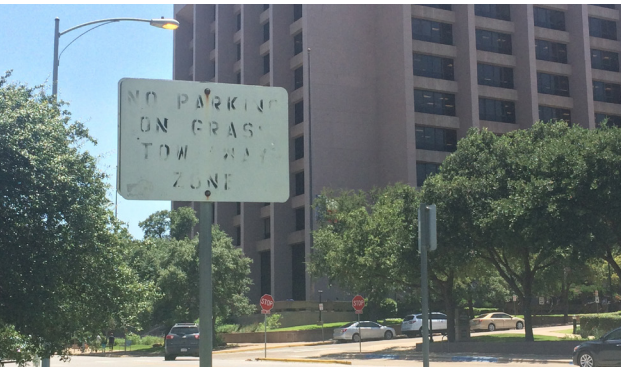
4 Signs are of poor quality and poorly maintained.

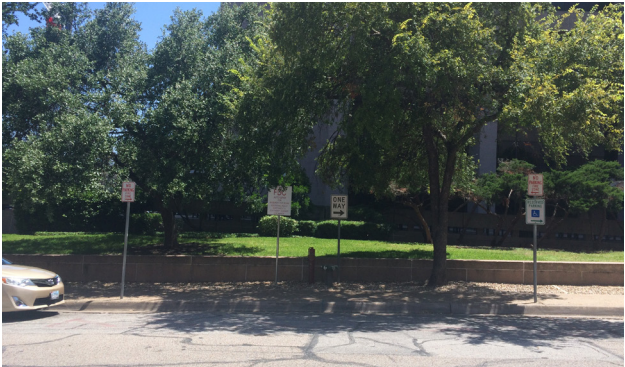
4 Signs lack visibility due to placement and landscaping.

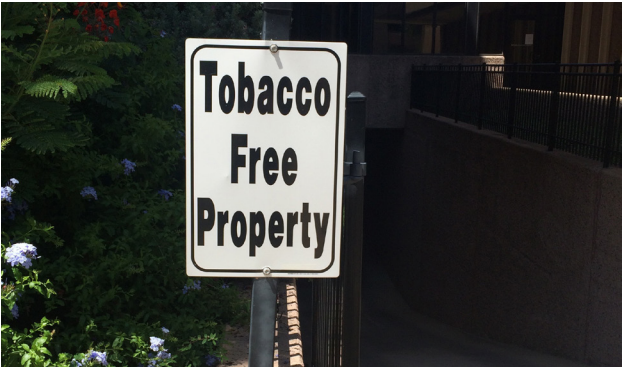
Signage uses multiple sign formats and typography.

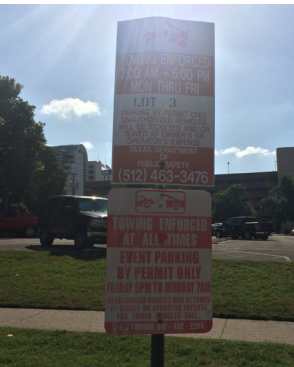
Regulatory signs are overwhelming to user and repetitive in nature.

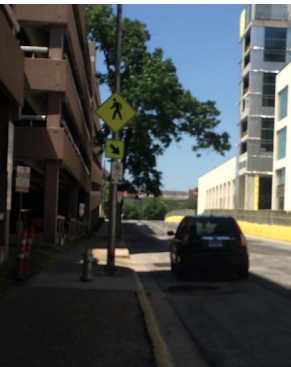
5 Infrequent pedestrian signage and odd placement.

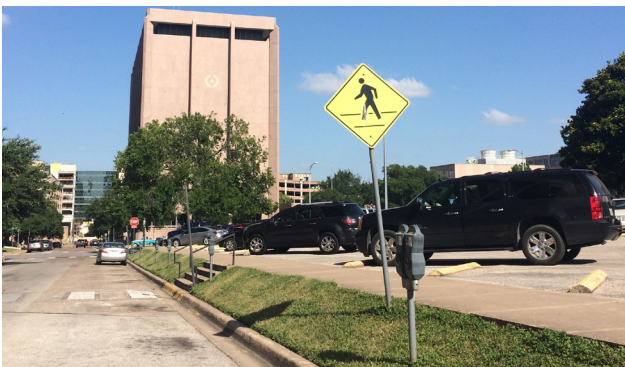
4 Infrequent pedestrian signage and odd placement.

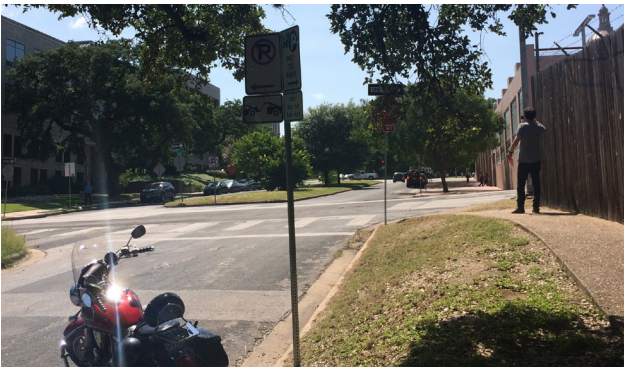
5 Crosswalks do not have consistent signs or markings.

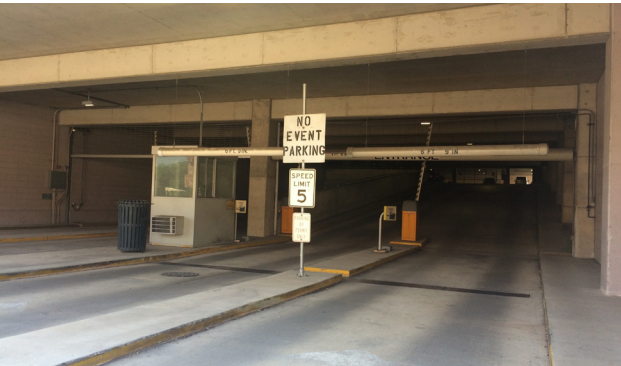
Garage entryways are unbecoming and unclean in nature. Messages vary in sign type, typeface and overall presentation.

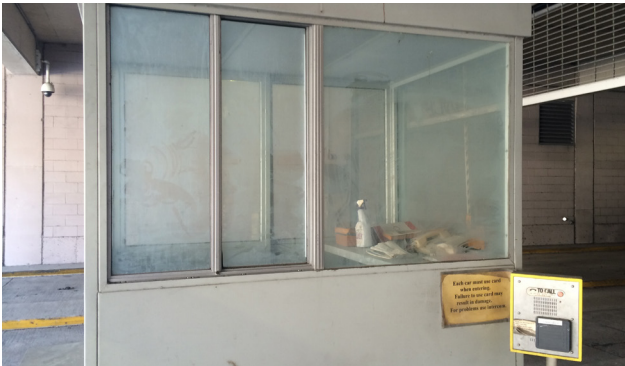
Attendant booths appear disheveled and in much need of refurbishment.

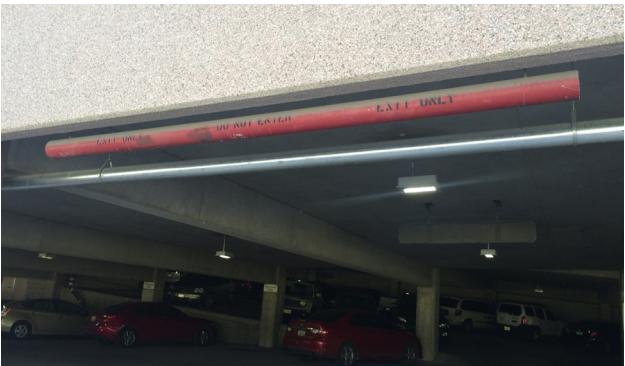
Lack of standard maintenance allows grime to collect resulting in illegibility of important user information.

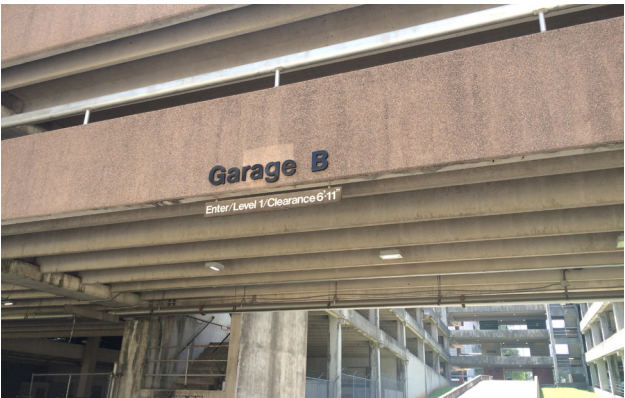
5 Clearance Bars are inconsistent in size and material. Legibility and typeface vary from garage to garage.

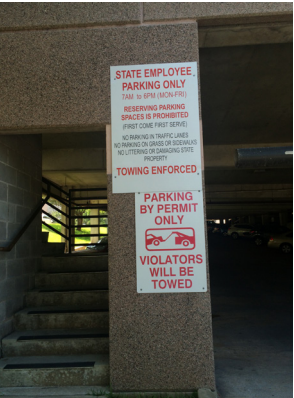
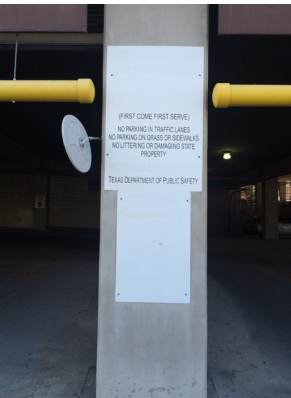
5 Regulatory information varies in sign type and legibility. Some signs are significantly faded and are no longer functional.

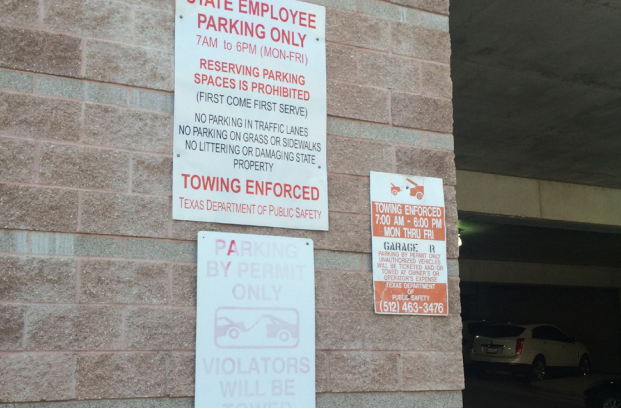
Regulatory signage is repetitive and overwhelming to the user due to various sign types, messages and legibility.
